Site Report: Fishing Battery Island

Original restoration completed in 2013

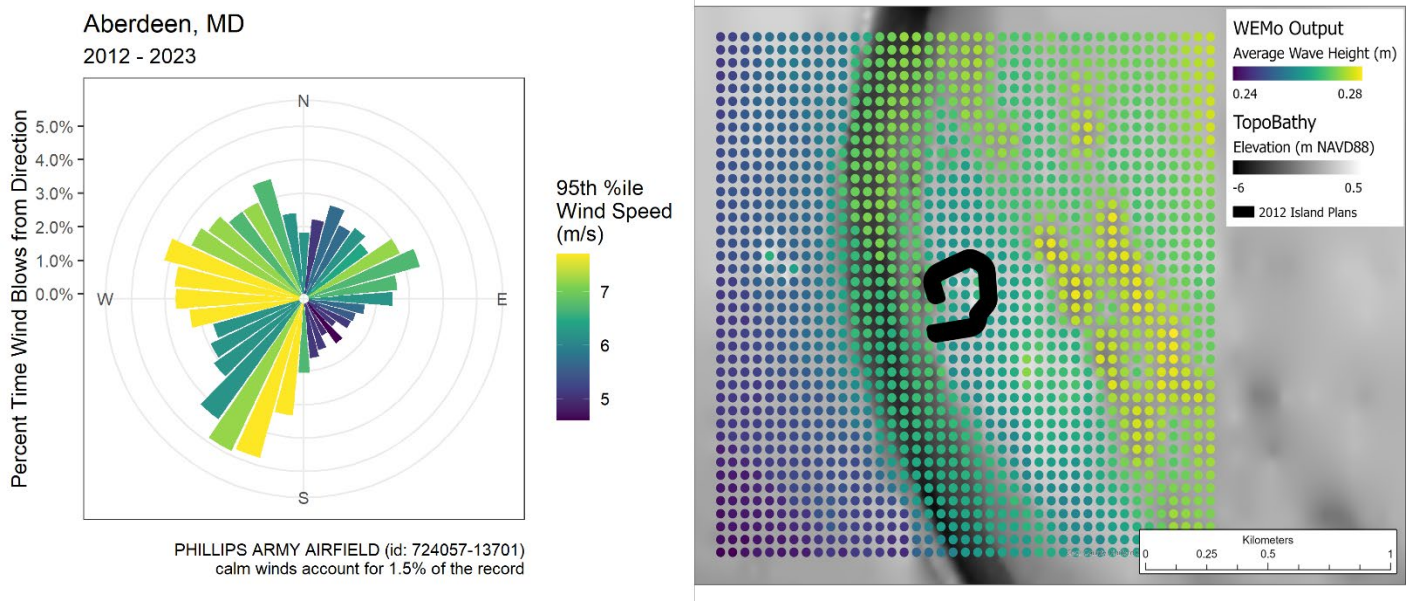
Figure 2. Average measured wind conditions over the project lifespan (left) were used to model wave energy conditions using the Wave Exposure Model (WEMo, right). Only the top 5% of wind events (intensity) were modeled. Colored points represent modeled average wave heights within a 2 x 2 km grid surrounding Fishing Battery Island. Gridded points are spaced 50 m apart. Grayscale background layer is bathymetry raster.

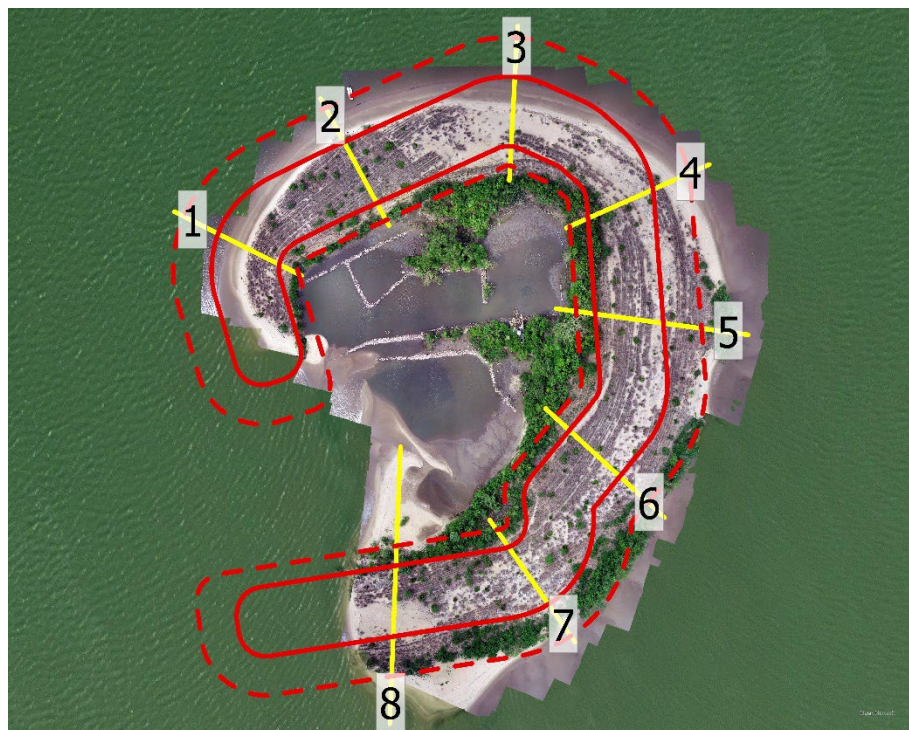
Comparison of Fishing Battery Island's 2013 (just after restoration) and 2023 extents indicates that much of the designed footprint has persisted since project construction (Figure 3). The exceptions are the island's northern shoreline and western-most extents (outer tips of the U shape) which have lost area due to erosion. In 2023, elevation survey data were collected along 8 transects perpendicular to the main spine of the island (Figure 3). Comparison of the surveyed elevations with the intended elevations along these transects highlights significant differences between the two. In general, 2023 surveyed elevations were ~50 cm (1.5 feet) lower than designed elevations across the high elevation spine of the island.

Figure 3. Design plan. Inner, solid polygon indicates the central spine that was designed to 7 ft MLLW. Outer polygon (dashed line) represents full spatial extent of intended project footprint. Perpendicular lines numbered 1-8 represent elevation survey transects occupied in 2023.

There was no available post-construction survey data for comparison so it is unclear how closely the final built project reflected the design, but assuming that the intended elevation was achieved, the island appears to have lost elevation over time. While the reason for such elevation loss is unclear, we hypothesize that gradual slumping of the steep slopes (likely exacerbated by human foot traffic) has played a role. The central higher elevation zone of the island is vegetated with Switchgrass (*Panicum virgatum*); which commonly occurs on dunes in this area of Maryland, indicating that despite the difference between the current and intended elevations, this portion of the island remains above Mean High Water.

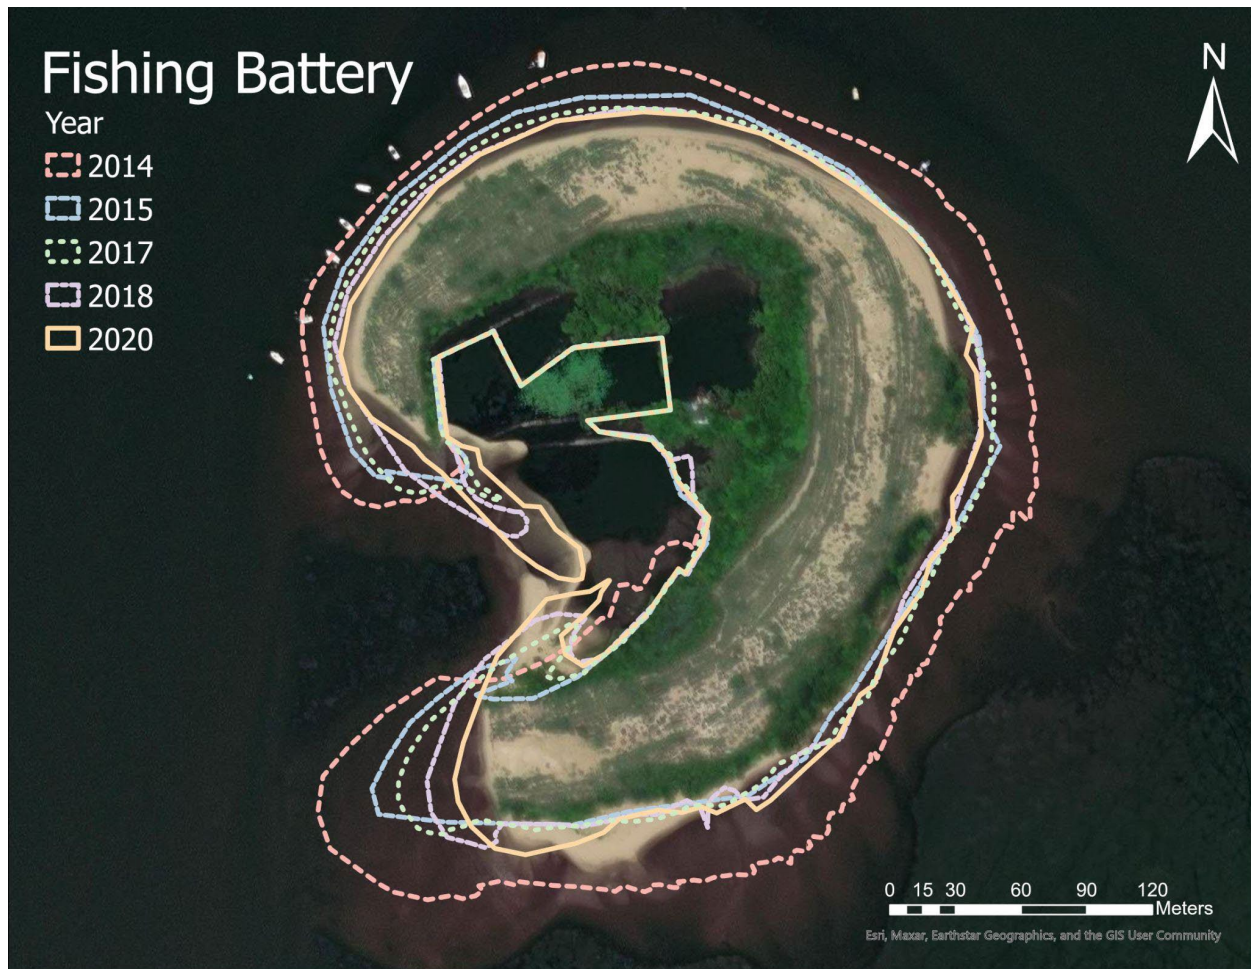
Figure 4. Shoreline position overtime as delineated from aerial imagery. Imagery used to generate these shorelines was obtained from the MD iMAP system.

In 2014, 1 year after project completion, the total areal extent of the island was approximately 16 acres. By 2015, the total area of the island had declined to 10 acres and has remained relatively stable since then. Most of the loss occurred on the western tips of the island, closest to the navigation channel.

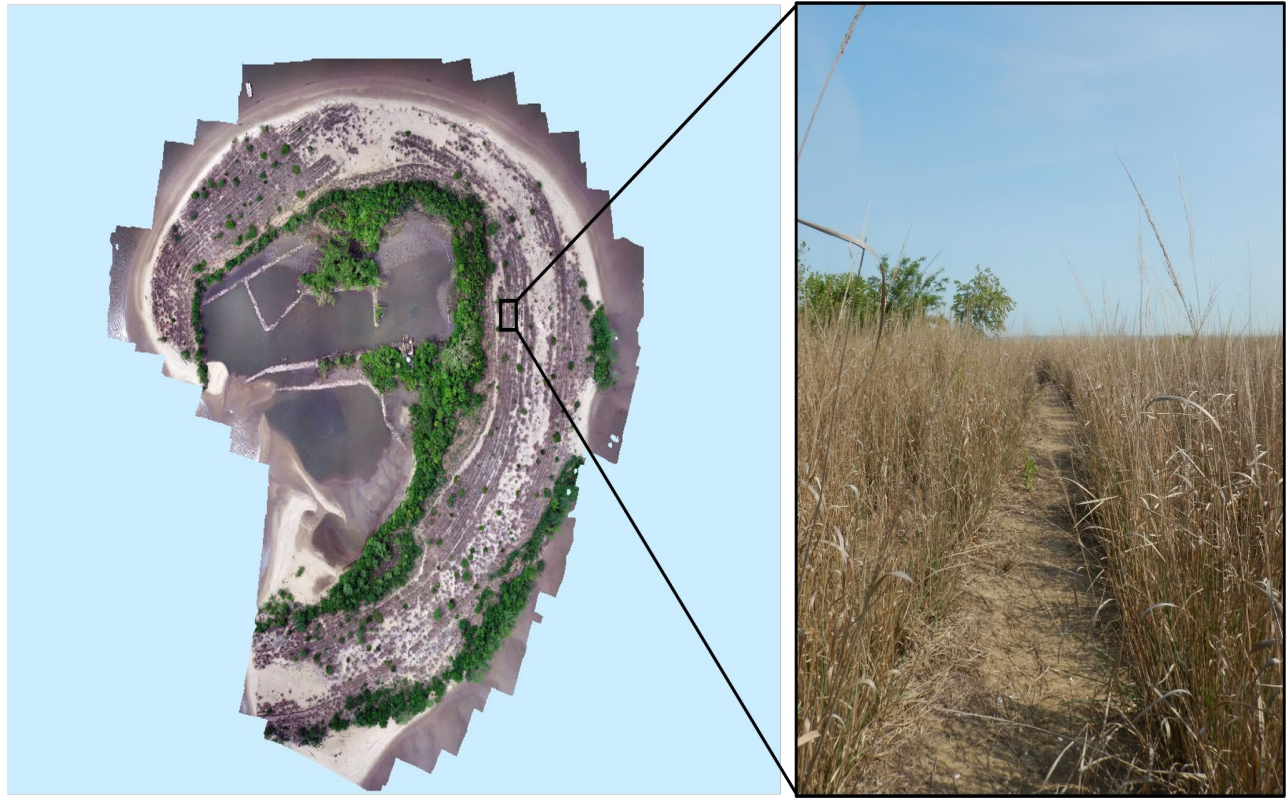
As of 2023, the switchgrass plantings were successful and seemed to be thriving although they had not coalesced into a dense canopy; the planting rows were still evident from aerial imagery (Figure 5). A number of tree species had recruited to the area naturally including locust, oak, sycamore and willow variatals including a dense and tall (> 30 ft) stand of trees along the southeastern shoreline, none of which were planted. The original design included planting emergent grasses in the intertidal zone along the inner shoreline of the island in an attempt to establish a marsh fringe. As of 2023, there was no evidence of the planted marsh vegetation along the inner shoreline, but most of that shoreline was densely vegetated with trees.

Figure 5. Composite drone imagery collected in 2023 (left) highlights the extent of vegetated vs unvegetated area 10 years post-construction. Trees and shrubs display as green, switch grass is brown and planting rows are still evident (right).
