# Site Report: Swan Island, Maryland

*Original restoration completed in 2019*

The restoration of Swan Island, Maryland was the result of a partnership between the U.S. Army Corps of Engineers and the U.S. Fish and Wildlife Service. This project used ~60,000 cubic yards of sediment dredged from a nearby navigation channel to elevate the island platform and restore its historical footprint.

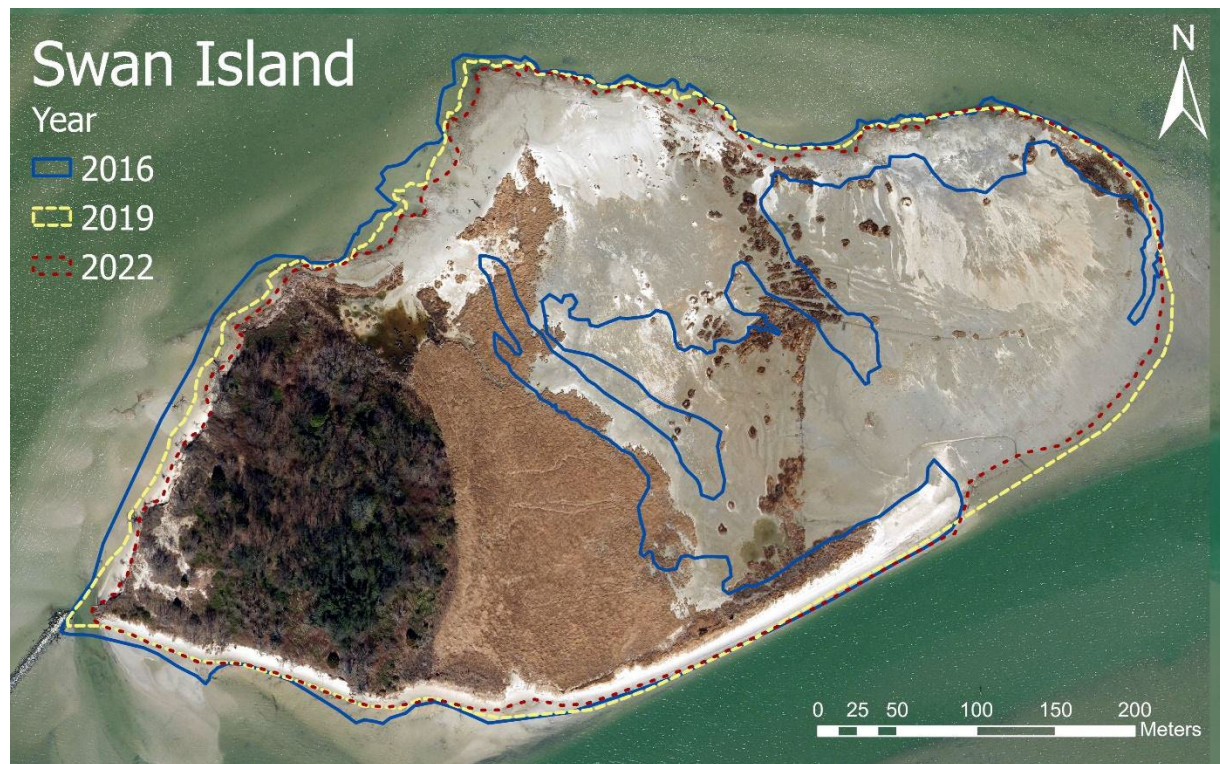
Figure 4. Shoreline position overtime as delineated from aerial imagery. Imagery used to generate these shorelines were 6-inch resolution orthoimages obtained from the MD iMAP system. The background image shown here is from 2022.

As of the writing of this report, the Swan Island placement project is relatively recent (5 yrs post placement) thus this description should be considered preliminary. Imagery-based evaluation of change in shoreline position over time (Figure 4, Table 1) indicates a significant increase in the extent of Swan Island habitat at intertidal or higher elevations as a result of the placement.

Although the target elevations were achieved, the success of vegetative plantings was variable across the spatial scale of the project. The *S. patens* planted in the area designed to be high marsh grew in rapidly, exhibiting dense cover by the end of the second growing season. The western-most created dune was rapidly colonized by lateral spread of existing, naturally occurring dune vegetation and expansion of the planted *S. patens*. The *S. patens* planted on the eastern dune did not survive the first growing season and that dune was rapidly flattened by overwash. The majority of the *S. alterniflora* planted in the large areas of the island intended to be low marsh habitat did not survive the first growing season. A portion (roughly one acre) of the area created to serve as low marsh was replanted in 2021. There wasn't enough funding available to support replanting the entire low marsh, so this effort was limited to the area deemed most susceptible to erosion. This secondary planting was partially successful: in the portion of the planting area that was furthest from the northern shoreline, the plants thrived and reached dense cover within 1 growing season. In portions of the planting area that were closer to the shoreline, there was no sign of the installed plugs after 1 growing season. This more northern portion of the re-planted area experiences greater waves and currents and many of the planted plugs were dislodged presumably, as a result of those forces. As of 2024, the majority of *S. alterniflora* (which still exhibited only patchy cover at that time) appeared to have been the result of lateral spread from native plants that survived the original placement action.

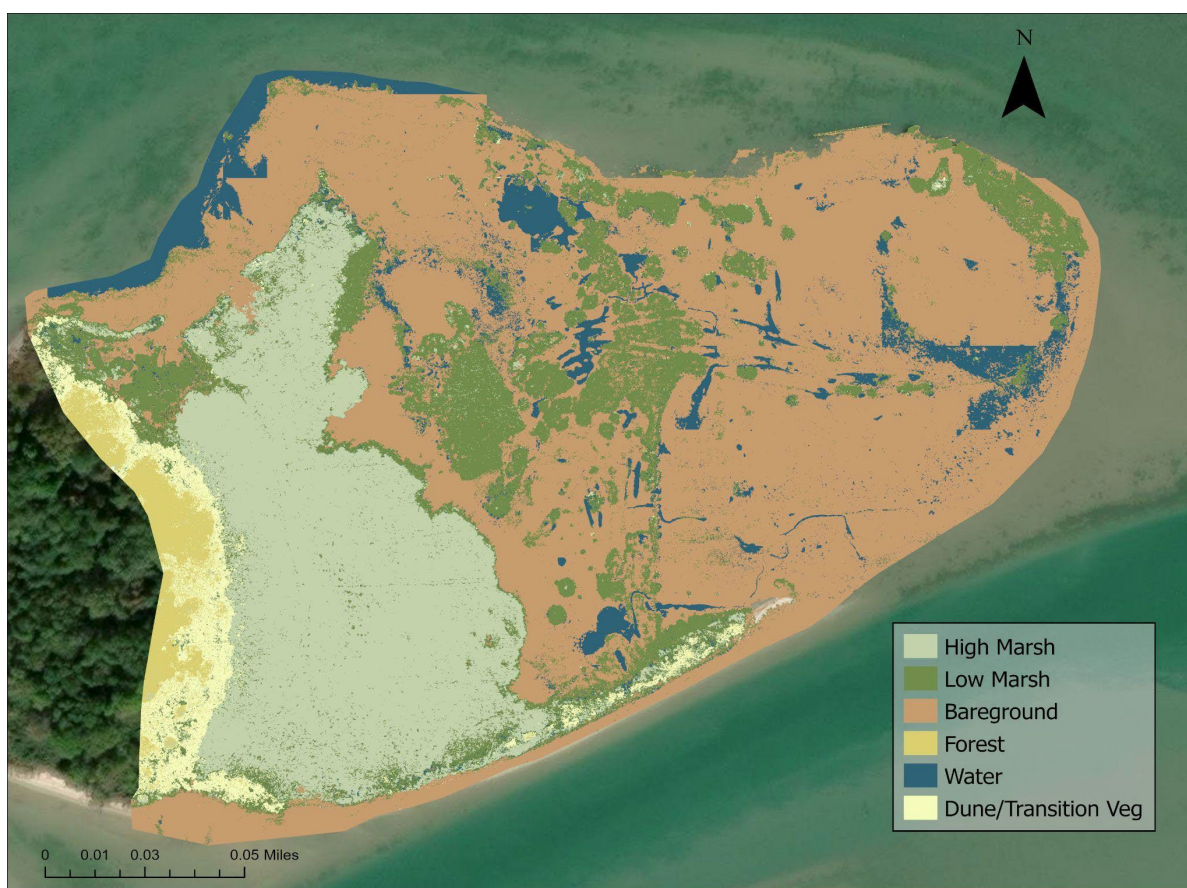
**Figure 5.** Drone-imagery based habitat classification created using supervised object-based image analysis in QGIS (QGIS Development Team 2025).

As of 2023, the area designed to serve as high marsh habitat was densely vegetated with *S. patens* and some natural vegetation (*Bacharris halimifolia*) was beginning to recruit to the area. In the area designed to serve as low marsh, vegetation, where present, was dense, but large portions of the area remained unvegetated (Figure 5). In several locations within the low marsh, the vegetation had trapped enough sediment to form mounds that were 30-50 cm (1-1.5 ft) above the existing low marsh elevation. The tops of several of the mounds were vegetated with high marsh and/or dune vegetation. Although the majority of the low marsh habitat remained unvegetated, it was still within the appropriate elevation range to support *S. alterniflora*.

As long as the appropriate elevations are maintained it appears likely that lateral expansion of the established vegetation will continue.

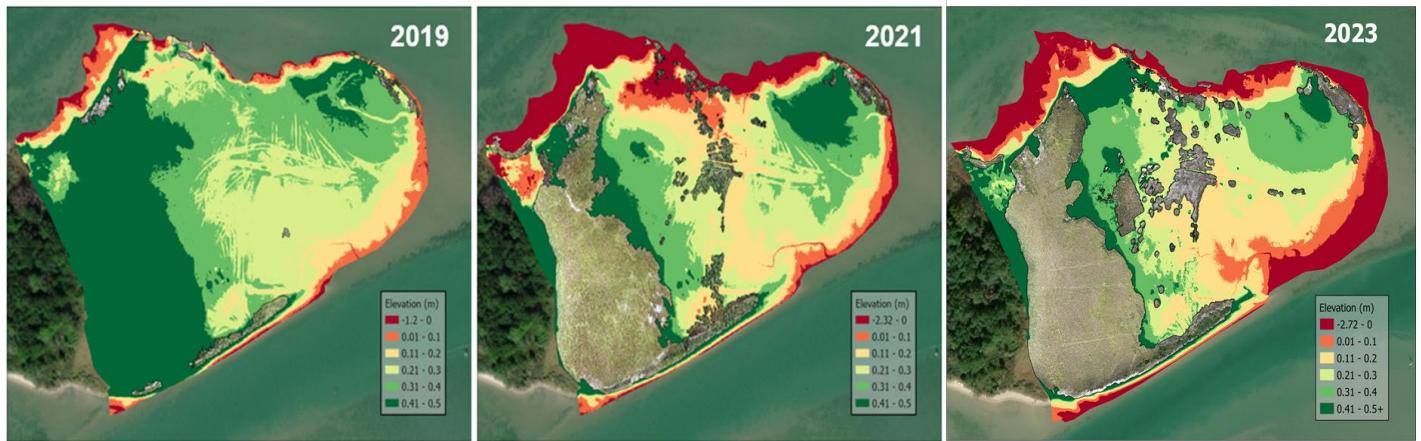
Figure 6. Digital Elevation Models of Swan Island created from high resolution drone imagery. Colors correspond to elevation of the sediment surface where no vegetation is present. Elevation categories are in units of meters NAVD88. Red = < 0m, Yellow = 0.21-0.3 m, dark green = > 0.41 m.

As of 2023, almost 5 years post-construction, the majority of the project footprint still reflected the design conditions. The one exception to this was the low dune on the northeastern shoreline (Figure 6). The sediment that was placed to create the dune was washed southward across the island surface and spread across the low marsh area landward of the dune.

In the zone intended to serve as high marsh, the planted vegetation flourished quickly and has consistently exhibited dense cover. The larger, eastern lobe of the island that was designed to serve as low, regularly flooded marsh habitat remained largely devoid of vegetation five years after project completion. It is likely that this area will eventually become vegetated through lateral spread if it remains at an appropriate elevation to support low marsh vegetation. Additional plantings would still be appropriate for this site as the presence of a vegetative canopy will help to defend against erosion of the placed sediments and ensure long-term project success. To date, the project has met the objectives of resulting in an island surface that is more resilient to future sea level rise and that supports a wider range of habitats.
