# Site Report: Duke Marine Lab

*Original restoration completed in 2002*

This site was created through a collaboration between Duke University Marine Lab and the North Carolina Coastal Federation with funding from NOAA's Community Based Restoration Program. The project converted a previously hardened shoreline to a marsh sill living shoreline.

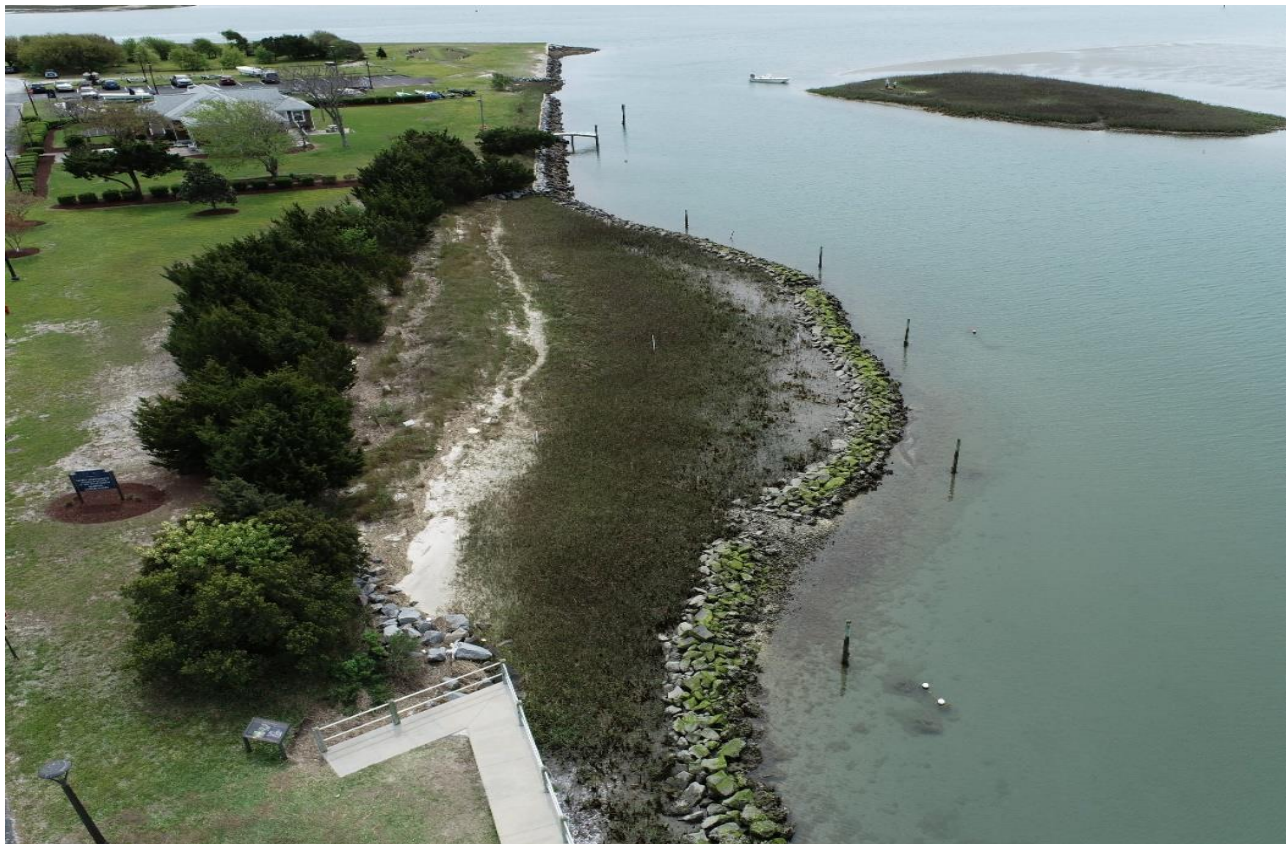
**Figure 1.** Aerial image of Duke Living Shoreline from 2019

This project involved the replacement of a hardened shoreline on Pivers Island in Beaufort, NC with a granite sill living shoreline (Figure 1). The original hardened shoreline was a seawall with cement fish pens that extended from the seawall to approximately 50 feet offshore. The seawall and fish pens were completely removed and the living shoreline was constructed **as a demonstration of the potential for living shorelines to defend against erosion while also providing valuable shoreline habitat.**

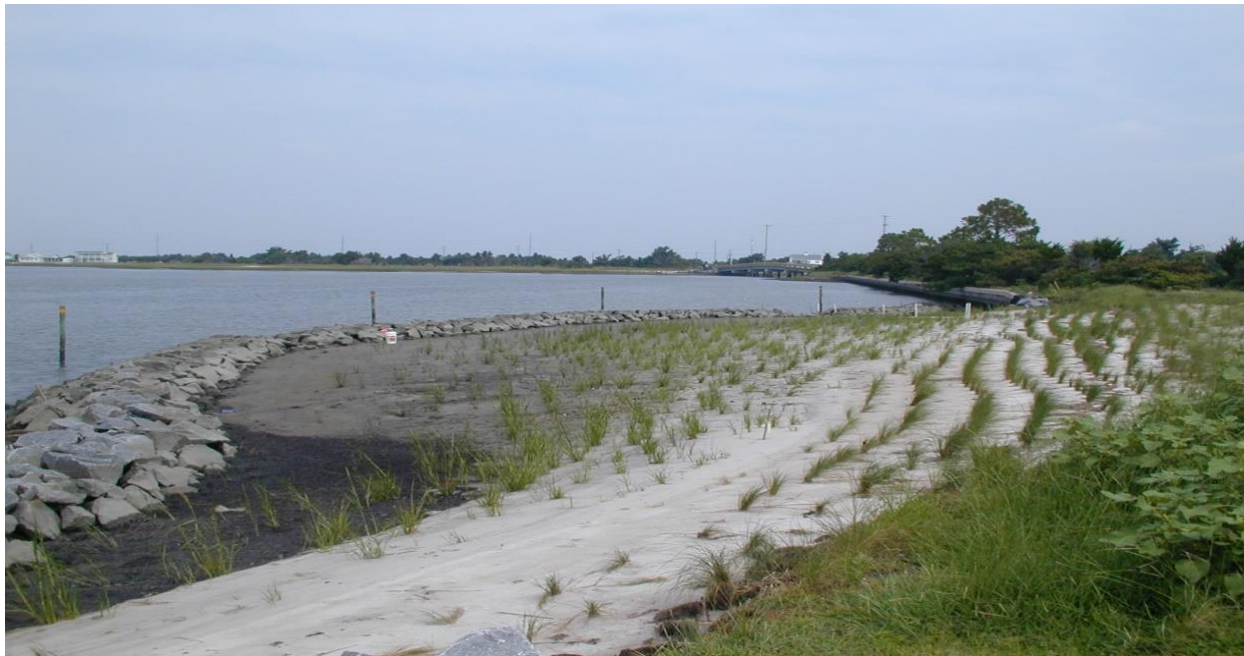
**Figure 2.** Duke Marine Lab Living Shoreline shortly after construction and planting.

Construction of the living shoreline involved placement of clean, sand fill that was graded to an 8% slope, followed by installation of an 80 m long granite sill at the shoreward edge, and creation of a sand berm (~ 2 feet tall) at the marsh/upland transition. The berm was planted with red cedars. The marsh component was grid-planted with nursery grown plugs of *Spartina alterniflora* at low marsh elevations and *Spartina patens* at high marsh elevations (Figure 2). The sill was built as a pyramid of granite rubble with a base elevation near the mean low water mark and a peak elevation just above mean sea level. The sill is curved so that both ends join the existing sea wall, and includes two drop downs (sections where the max sill height is ~ 1 foot lower than the rest of structure), each 6 feet in length, to allow fish utilization of the marsh. The long-term monitoring plan for this site involves documenting vegetative community composition and total cover at 30 fixed locations. In addition, two surface elevation tables (SETs) installed at this site provide the ability to track changes in elevation over time with mm scale resolution. The SET data collection began in 2004 and the vegetation data collection began in 2008.

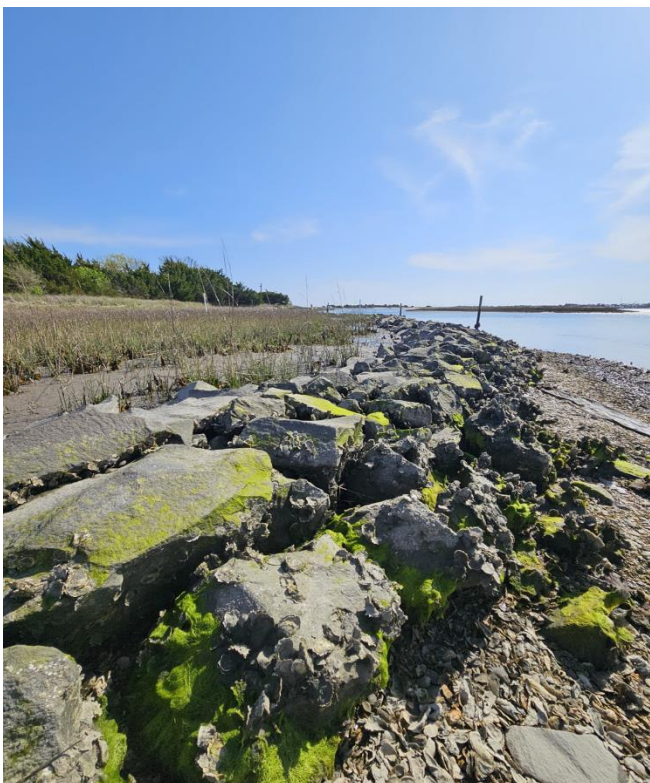
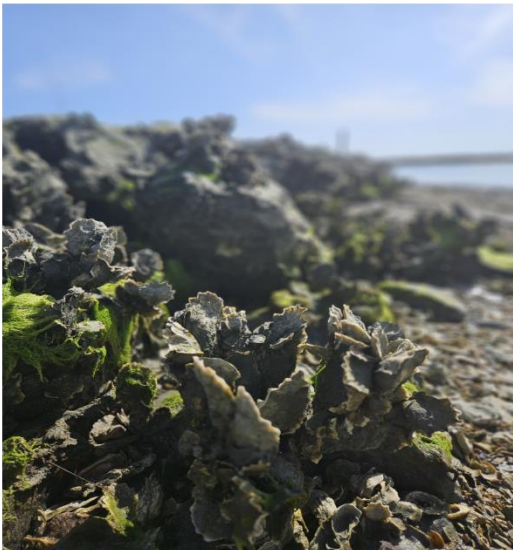
Figure 4. Duke Marine Lab Living Shoreline Sill (left) with close up of oyster colonization (right)

The rock sill at the shoreward edge of this site has effectively held the line against shoreline erosion. Wave gauges deployed waterward and landward of the sill suggest that incident waves are attenuated by up to 88%, with an average wave attenuation of 45%. For reference, average wave attenuation at a nearby natural and restored oyster reefs were 16% and 18%, respectively. Comparison of elevation surveys conducted on the sill just after construction and again in 2025 indicate that the sill elevation has been consistent over time (i.e., there has been no measurable settling of the structure under its own weight, or wave-induced movement). The sides and base of the sill have become encrusted with oysters (Figure 4) and independent research has confirmed that this sill and others like it support higher abundances and diversity of fish than nearby shorelines without sills<sup>1</sup>. Over the lifespan of the Duke Living Shoreline site, the nearby natural marsh that serves as a reference site has experienced measurable edge retreat.
