# Site Report: Jumbile Phase II

*Original restoration completed in 2004*

Jumbile Cove Phase II restoration was implemented in the winter of 2003-2004 by Texas Parks and Wildlife Division, with funding from the Galveston Bay Estuary Program, the Texas General Land Office, NOAA's Community Based Restoration Program, and the US Fish and Wildlife Service Coastal Program. The project footprint encompassed 48 acres, in which 18 acres of intertidal habitat was constructed.

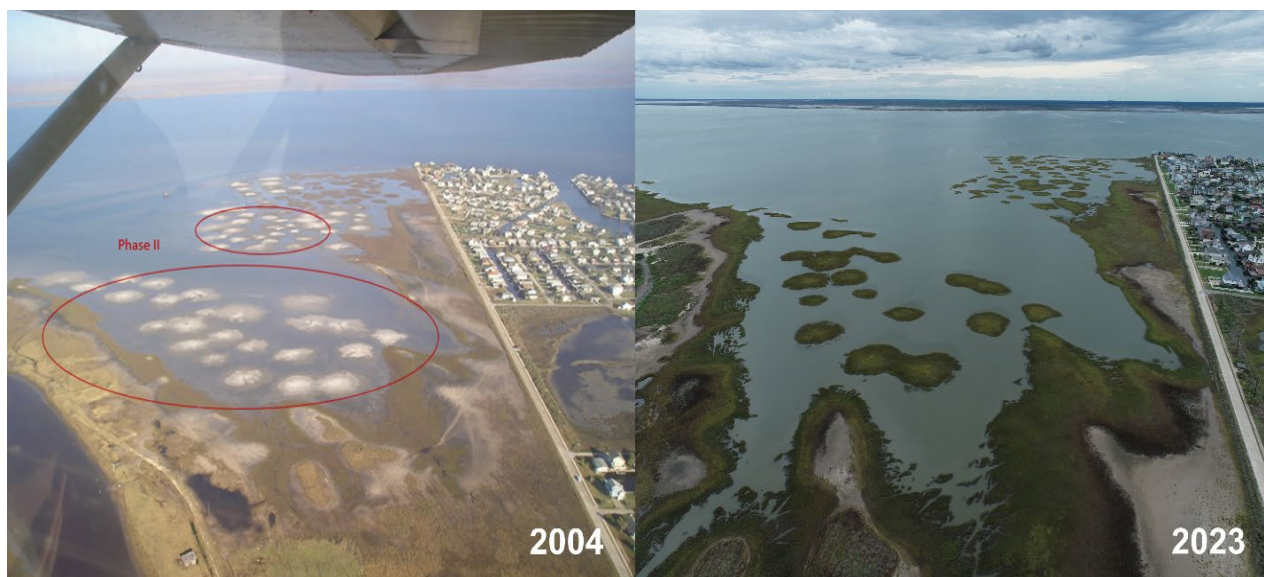
**Figure 1.** Change in extent of marsh habitat in the western portion of Jumbile Cove over time.

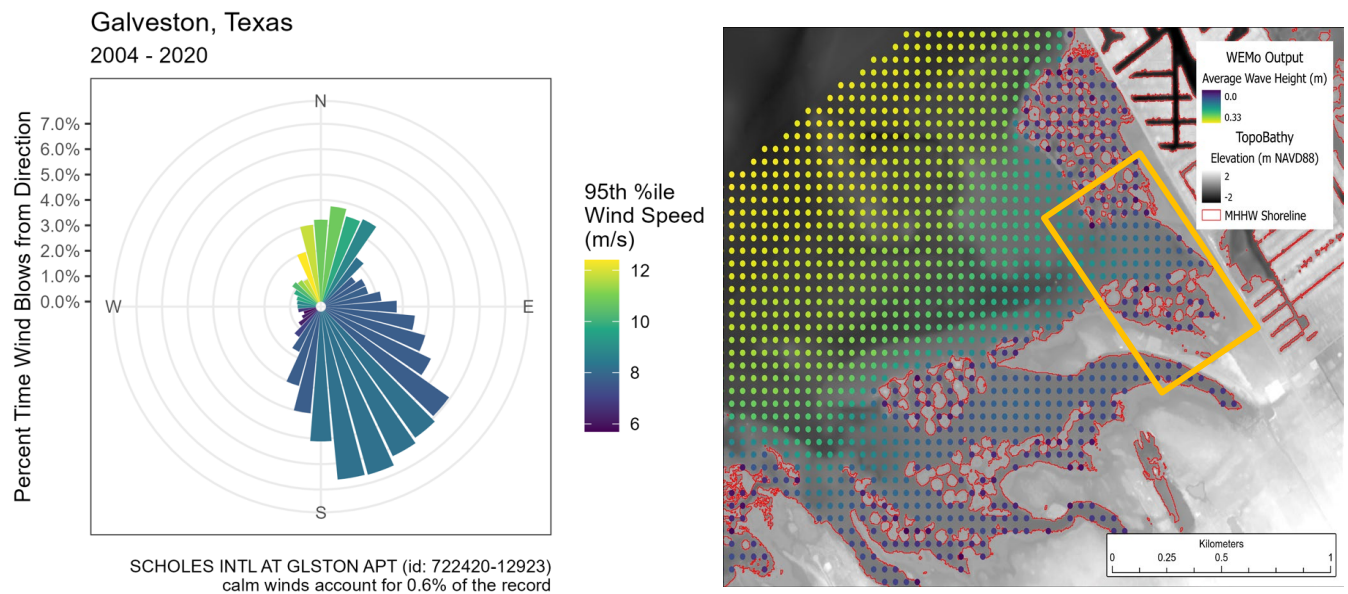
**Figure 2.** Average measured wind conditions over the project lifespan (left) were used to model wave energy conditions using the Wave Exposure Model (WEMo, right). Yellow box in the right panel outlines the approximate project footprint.

While winds from the SSE are dominant in this region, the project site is relatively well-protected from southerly winds due its location on the northern shore of Galveston Island. In contrast, the site is fully exposed to winds from the north, and the strongest winds tend to blow from the NNW. Despite this wind exposure, shallow nearshore water depths limit average wave heights just offshore of the project area (Figure 2).

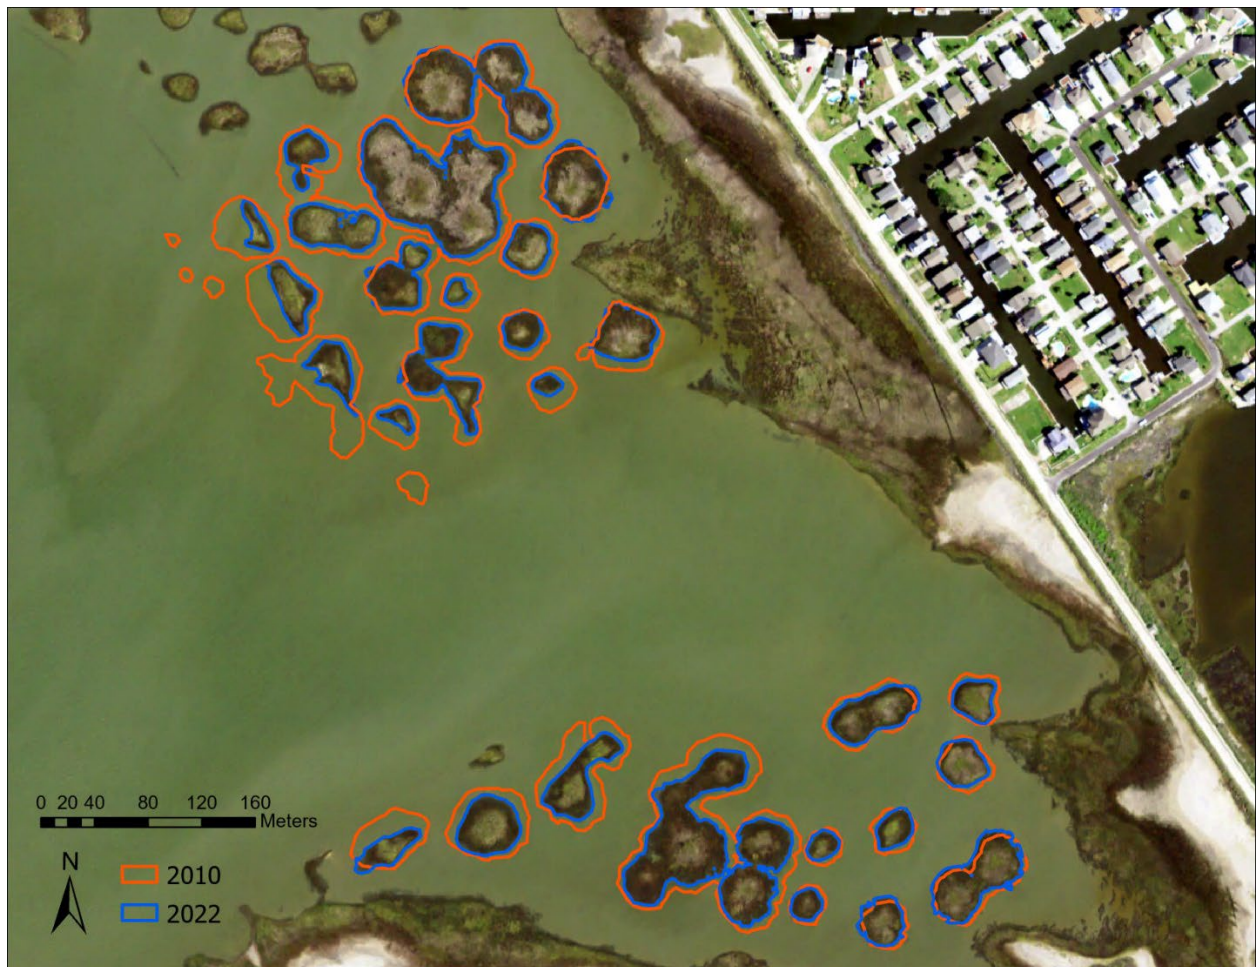
**Figure 3.** Digitized shorelines from 2010 and 2022 (using imagery available from the Natural Agriculture Imagery Program; NAIP). Shoreline position was defined by the outer extent of vegetation on each mound.

As of 2023 (19 years after project construction) 47 of 55 mounds constructed within the Jumbile II footprint are still present. Several mounds, primarily those that are on the seaward edge of the complex, have experienced significant losses in total area and have been reshaped by waves. Mounds with a more interior placement within the complex have been relatively stable in area over time. Changes in areal extent of constructed intertidal habitat based on delineation of the lowest extent of vegetated shoreline allow for an analysis of changes in total areal extent over time. This comparison indicates a 33% reduction in intertidal area over the past 22 years. (2010 total area = 17.1 acres, 2022 total area = 11.4 acres). The bulk of these losses has been from erosion of the wave exposed sides of outer islands.

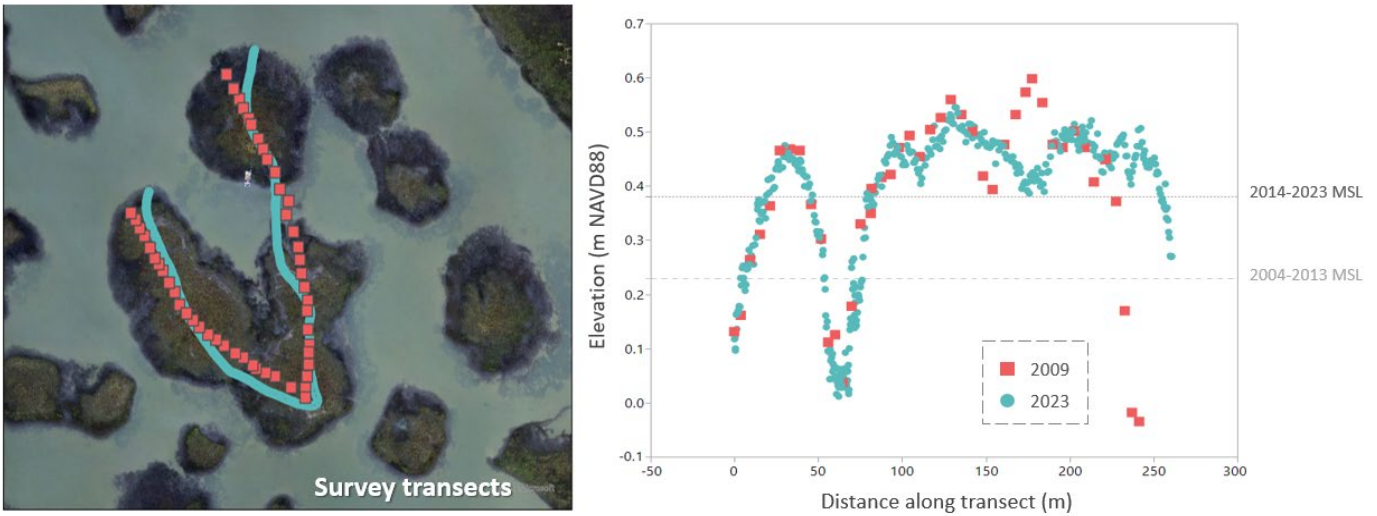
**Figure 4.** Elevation data collected by repeat GPS surveys of the same transect in 2009 and 2023 indicate that elevations of interior mounds have remained stable over time.

The target elevation for constructed mounds was 0.67 m [2.2 ft] NAVD88 based on the elevation distribution of *Spartina alterniflora* on nearby natural shorelines. Elevation surveys conducted in 2009, 5 years after project completion, showed some early loss of elevation which was hypothesized to be the result of settling and spreading of the mounds under their own weight, but repeat surveys of those same transects indicate that they have been relatively stable since 2009. In the time since project implementation, local mean sea level has increased by 25 cm [9.8 inches]. Visual inspection of time

series aerial imagery illustrates the slow colonization of the interior, higher elevation portions of the mound by wetland vegetation, a trend that has likely been facilitated by sea level rise.

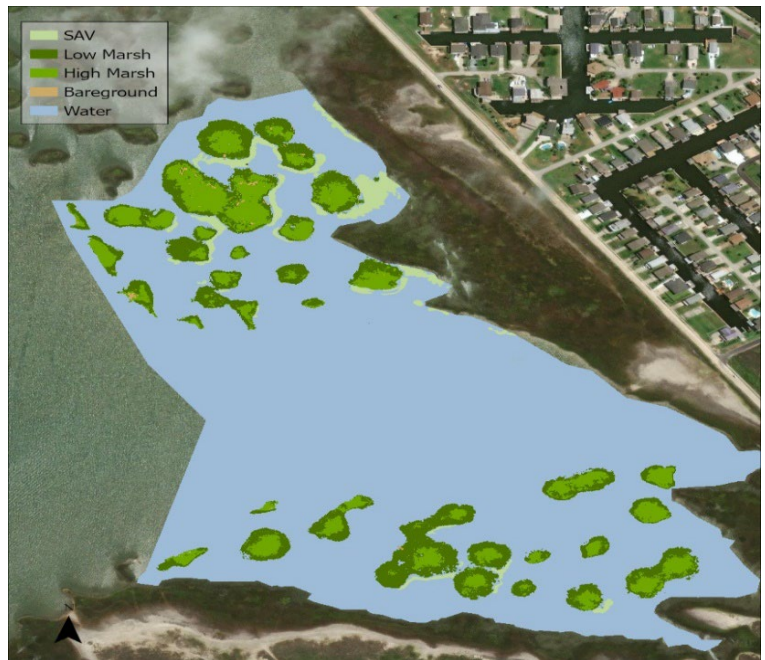
**Figure 5.** Habitat distribution as of 2023

As of 2023, the mound perimeters were vegetated with a monospecific band of tall form *S. alterniflora*. Mound interiors were vegetated with a mixed community of shorter growing *S. alterniflora*, *Salicornia spp.* and *Batis maritima*. We also noted the presence of sparsely distributed young black mangroves *Avicennia germinans* (~30 cm [1 ft] tall) on many mounds. Multiple patches of the seagrass *Halodule wrightii* were present within the project footprint, predominantly on the leeward side of mounds. Analysis of UAS imagery collected during the 2023 monitoring effort suggests that approximately 1.5 acres of *H. wrightii* were present at that time.
