Site Report: McAllis Point

Original restoration completed in 2010

The McAllis Point restoration project was implemented by the Texas Parks and Wildlife Division and Texas General Land Office with funding from NOAA through the American Recovery and Restoration Act (ARRA). The project involved restoration of 64 acres of intertidal habitat complex through the creation of 50 marsh mounds. Restoration at McAllis Point was completed in 2010.

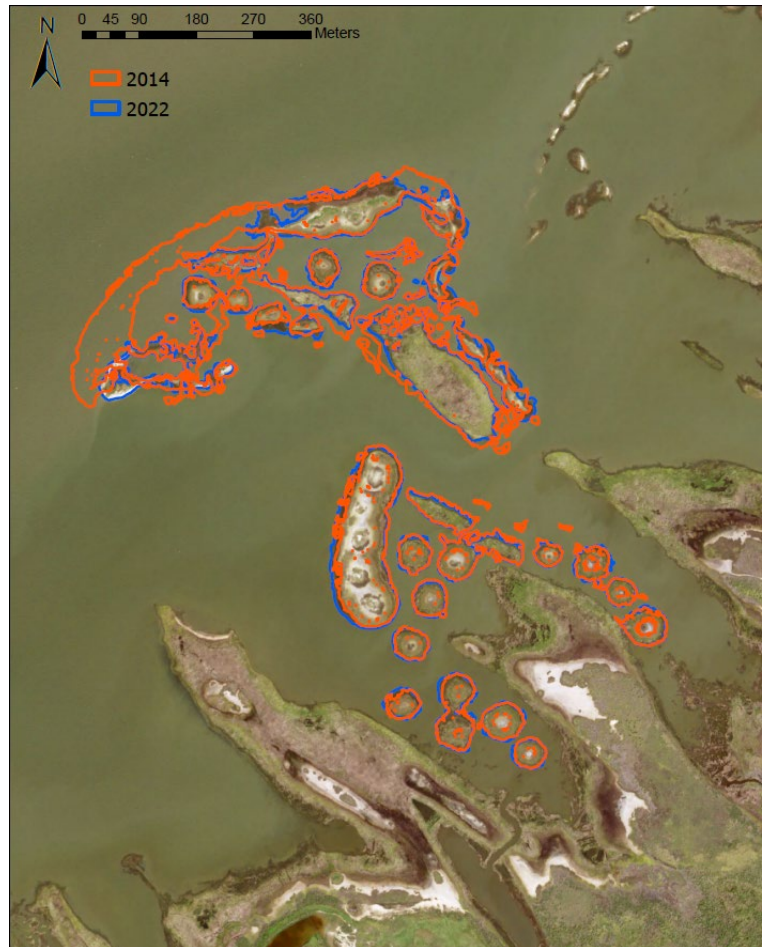
Figure 3. Digitized shorelines from 2014 and 2022 (using imagery from the Natural Agriculture Imagery Program; NAIP). Shoreline position was defined by the outer extent of vegetation on each mound.

Evaluation of changes in shoreline position indicate a 14% decrease in total created mound area (from 37.5 to 32.25 acres) between 2014 and 2022 (Figure 2). The restoration was completed in 2010 and the northernmost section of perimeter mound was already highly eroded by 2014 (the first date with usable imagery). Most of the area lost between 2014 and 2022 was from continued erosion of the northern perimeter. The existing parcels of marsh that were present within the project area prior to restoration appear to be largely unchanged and this is true even for patches of natural marsh that were directly behind the outer line of perimeter mounds (which has since eroded away).
