# Site Report: Swan Island, Maryland

*Original restoration completed in 2019*

The restoration of Swan Island, Maryland was the result of a partnership between the U.S. Army Corps of Engineers and the U.S. Fish and Wildlife Service. This project used ~60,000 cubic yards of sediment dredged from a nearby navigation channel to elevate the island platform and restore its historical footprint.

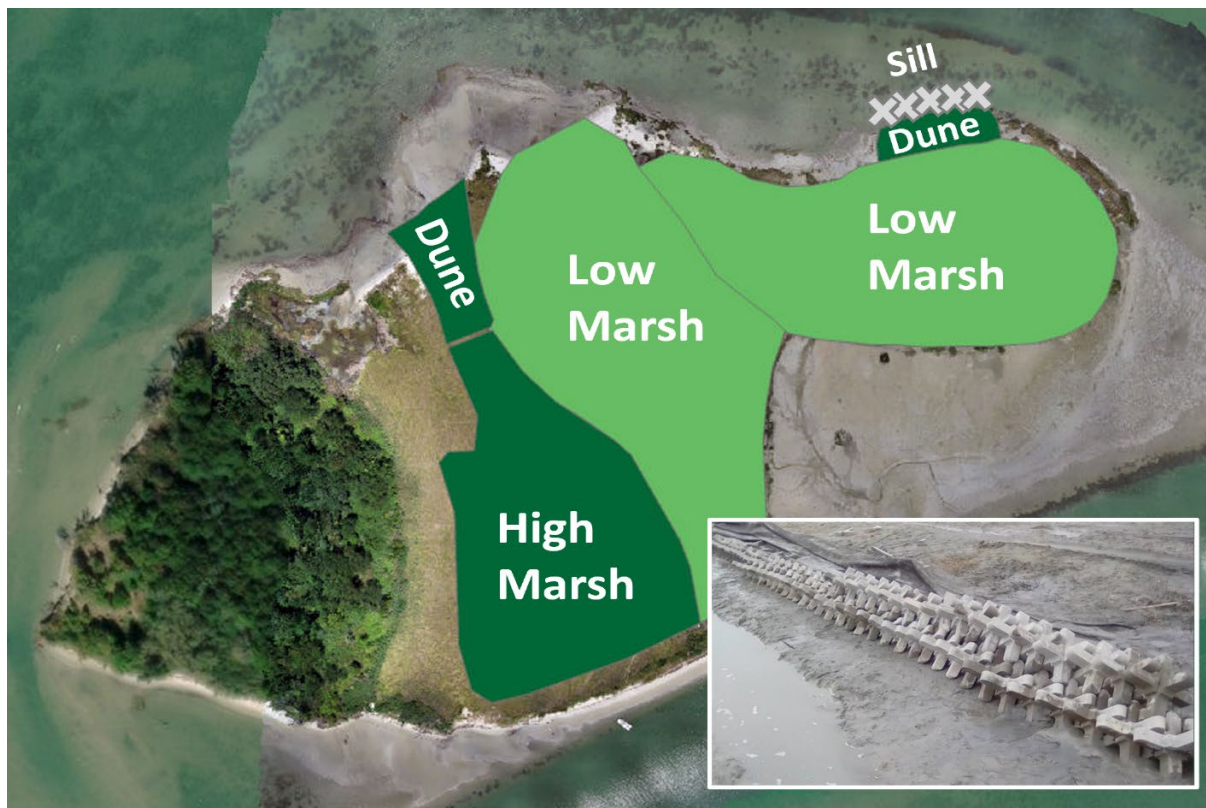
As part of the restoration effort, a shore-parallel sill of stacked 2 ft concrete armoring units (A-Jack®, Contech; West Chester, OH) was installed along the northeast shoreline (Figure 2). The structure was pyramidal (2 blocks wide on the bottom, one block on top) and designed to extend to 2.0 ft MLLW.

Figure 2. Map of Swan Island indicating relative position of target vegetative communities and Sill. Inset: Sill of stacked A-jacks units.

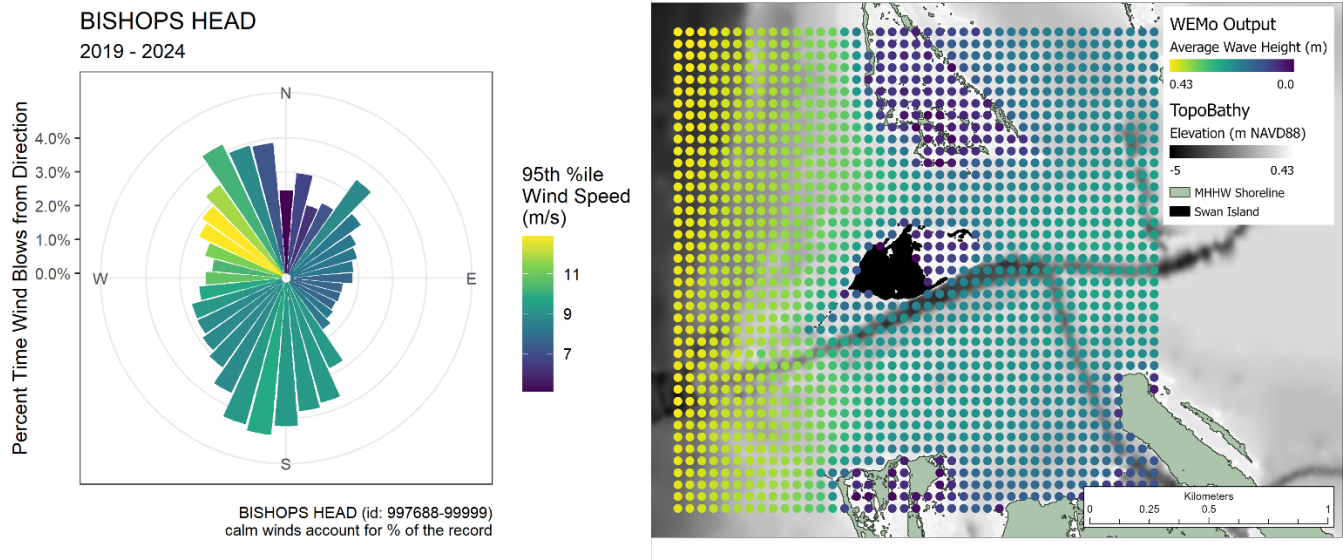
Swan Island is bordered on its southern shoreline by the navigation channel that provides access to the town of Ewell. Aside from the channel, water depths in the area directly surrounding the island are less than 3 feet. While winds in this region most commonly blow from the south, the strongest winds tend to come out of the NW (Figure 3). Swan Island is relatively sheltered from wind waves coming from the east and south however, it is fully exposed to waves coming from the west and northwest (Figure 3). Analysis of time series aerial imagery clearly indicates erosion of the northern shoreline in recent decades. Tidal amplitude in this region of the Bay is ~1.5 feet. The average height of waves impacting the northern shoreline of Swan Island ranges between 15 and 25 cm (6 – 10 inches).

Figure 3. Wind conditions (top 95% of wind events) over the project lifespan (left) were used to model wave energy conditions using the Wave Exposure Model (WEMo, right). Colored points represent modeled average wave heights within a 2 x 2 km grid surrounding Swan Island. Gridded points are spaced 50 m apart.
